NASA TN D-3409

MECHANICAL AND PHYSICAL PROPERTIES OF THE ECHO II METAL-POLYMER LAMINATE

by C. L. Staugaitis and L. Kobren Goddard Space Flight Center Greenbelt, Md. Approved he public relection
Distribution Unlimited

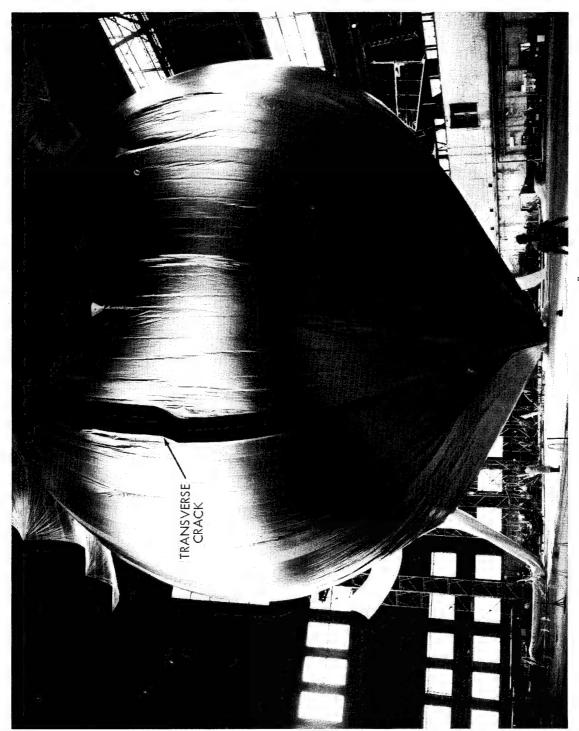
The origin of the fracture in balloon #11 occurred in gore #37 between tie-down patches #5 and #6 and proceeded to propagate vertically in both directions generating separate fracture paths (Figure 1).

Visual examination of the fracture edges and adjacent areas indicated the presence of a particular surface flaw along which the crack traveled. Samples removed from the fractured gore and metallographically examined confirmed the visual observation that a lamination (flaw) existed in the balloon material. One particular lamination, which was found to be extremely detrimental, exhibited a characteristic "pop" sound when loaded in tension or under biaxial stress.

Tensile tests of this defective material revealed a significant drop in tensile strength due to the presence of these particular defects. The results indicated that specimens having defects failed at loads ranging from approximately 3 lbs. to 7 lbs. with most averaging 6 lbs. Samples of defect-free material, however, could easily sustain loads up to 10 lbs. or more.

Figure 1—Photograph showing failure area in balloon $^{\#}11$ (note transverse crack).

The results also reveal some degree of mechanical anisotropy in the X-15-2 material resulting in lower transverse strength properties but enhanced ductility when compared to longitudinal performance respectively. The plane of weakness reflected by these results parallels the failure mode observed in biaxially stressed test specimens and, more significantly, the actual initiation of a transverse crack culminating in the catastrophic failure of Balloon #11 (Figure 1).
